# Manhole Inspection Summary

Manhole # S53C\_\_055MH

Insp Date: **6/13/08 11:17 AM**

**Location** Address: **3210 e fayette st**

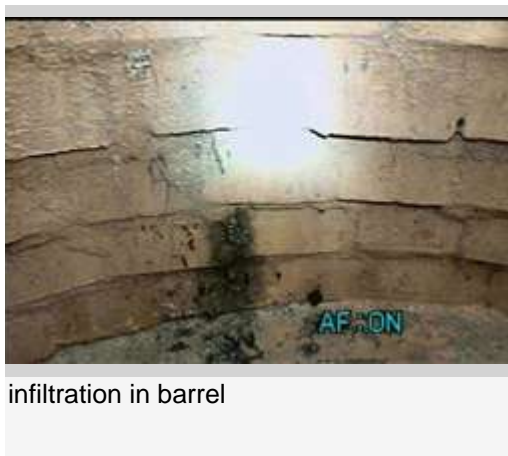
Defect 6

Infiltration: ☐ None ☐ Joint ☐ Cracks ☐ Mortar ☐ Roots ☒ **Wall**

infiltration in barrel

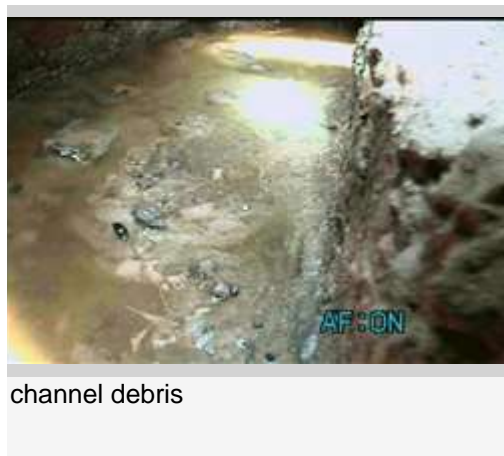
Defect 5

Condition: ☐ Sound ☐ Cracked ☐ Root Intrusion ☐ Deteriorated ☐ Leaks ☒ **Debris**

channel debris

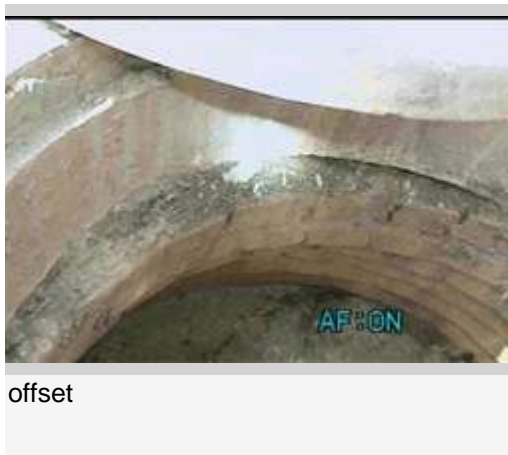
Defect 4

**Frame** Offset: **2** (in.) Condition: ☒ Sound ☐ Cracked ☐ Leaks

offset

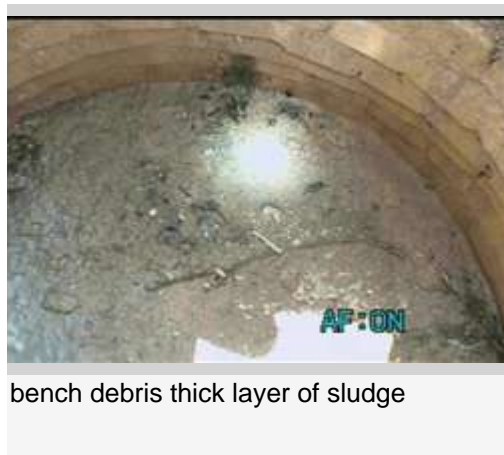
Defect 3

Condition: ☐ Sound ☐ Cracked ☐ Root Intrusion ☐ Deteriorated ☐ Leaks ☒ **Debris**

bench debris thick layer of sludge

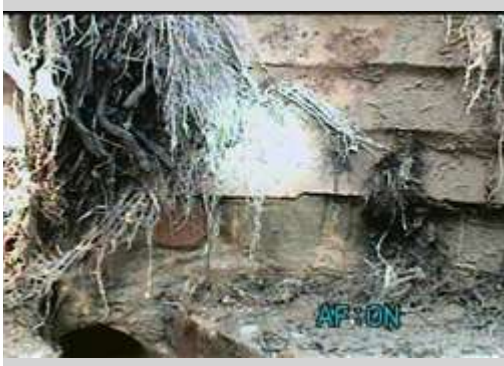
Defect 2

Condition: ☐ Sound ☐ Cracked ☒ **Root Intrusion** ☐ Loose Brick ☐ Deteriorated

roots in barrel

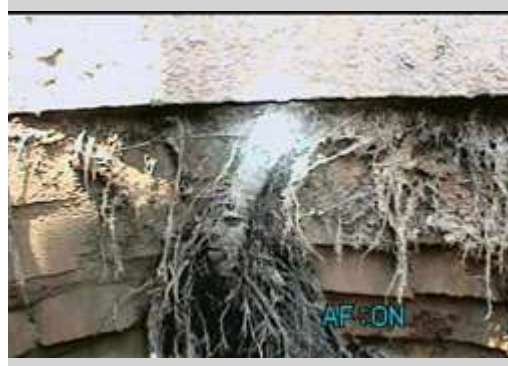
Defect 1

Condition: ☐ Sound ☐ Cracked ☒ **Root Intrusion** ☐ Loose Brick ☐ Deteriorated

roots in corbel
